CARPET STORE FIRE

Branford, CT

November 28, 1996

**Carpet Store Fire
One Fire Fighter Fatality
Branford, CT
November 28, 1996**

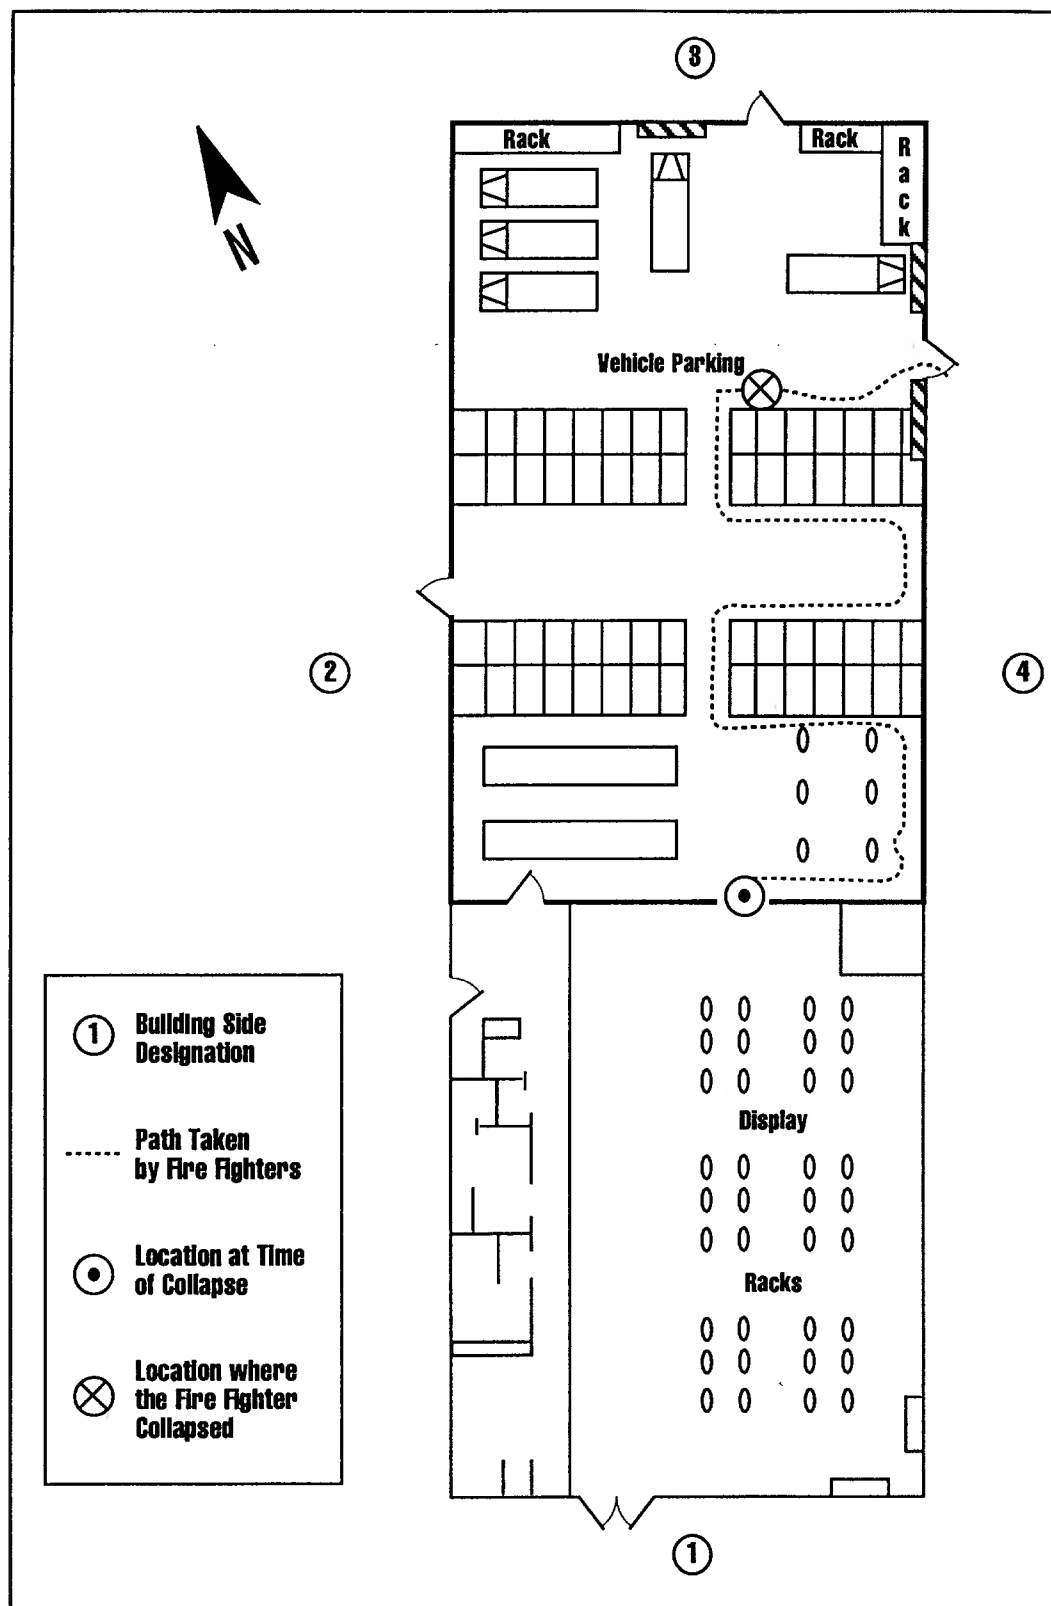
Figure 3: Path taken by fire fighters in their attempt to escape

When the trapped officer and fire fighter entered the part of the warehouse where the vehicles were parked, the Medic 1 fire fighter's air ran out. He took off his face piece and continued further only a short way. He was overwhelmed by the smoke and collapsed approximately 40 ft (12.2 m) from a door. The fire officer tried to pull the fire fighter out of the building but he was too big and heavy. The officer decided to continue on so he could find an exit and get assistance.

The officer found one of the overhead garage doors. This door was covered by wood boards, and the officer realized that he could not open it. He continued to search in the darkness and smoke until he found a personnel door. It was locked. Unable to see the door, he began feeling the entire door to determine what type of lock or locks

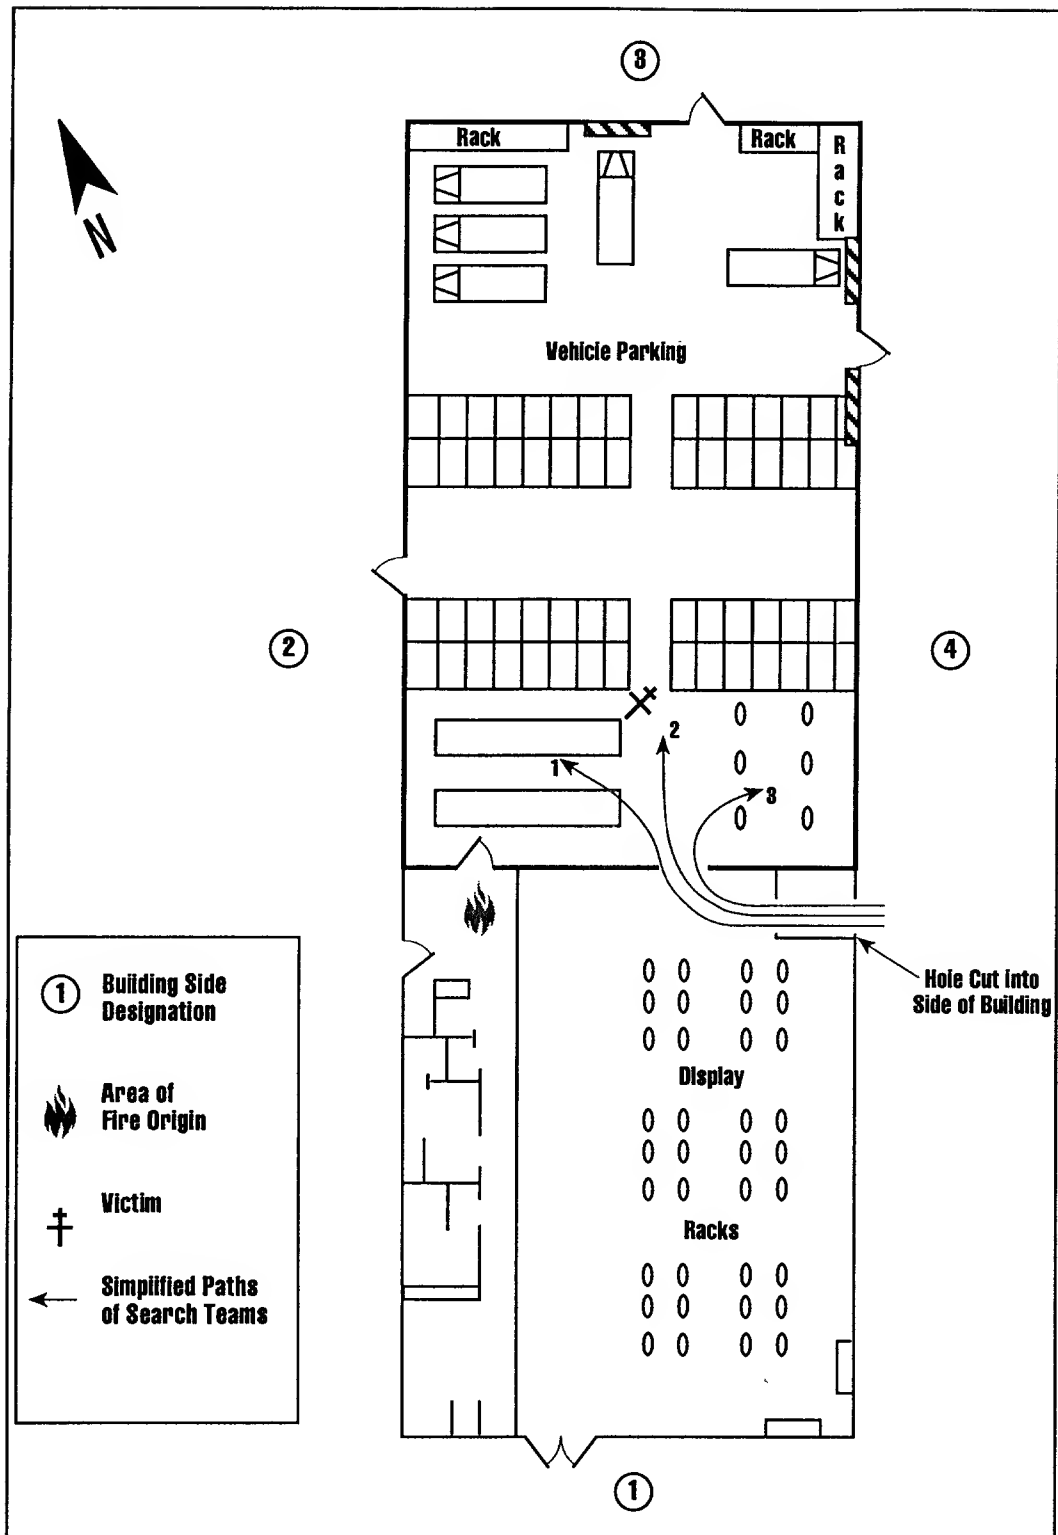
Figure 4: Rescue operation

Once the ladder pipe controlled most of the severe fire in the center of the building, three search teams, with six fire fighters in each team, entered the building with hoselines. They moved slowly, extinguishing the fire as they advanced into the building. The crews working in the building were relieved several times by new crews. The missing fire fighter was found at approximately 7:30 p.m., three hours after the initial dispatch of fire crews. Once the victim was located, all Branford fire fighters were withdrawn from the building. The victim was pronounced dead at 8:00 p.m. by a medical doctor who was also a Branford fire fighter. The victim was removed from the building by fire fighters from other towns. These fire fighters had come to the scene and had offered their assistance.

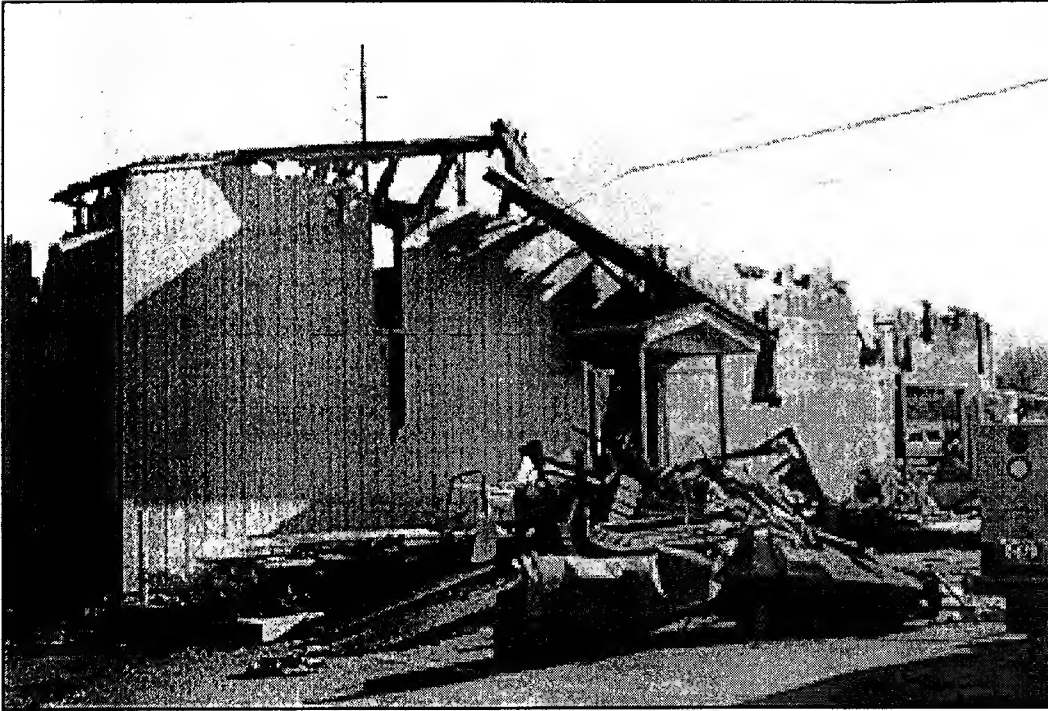
The entire building was destroyed by this fire. All of the wood trusses above the warehouse area and most of the wood trusses above the two showrooms were consumed. The most severe damage to building contents occurred in the warehouse, and in ceiling and tile showroom. In these areas, nearly all of the combustible and flammable materials were consumed. The contents of the carpet showroom were heavily damaged and in the office area furnishings, office equipment, and other combustible materials were moderately damaged. (*See Photos 1 – 4.*)

Photo 1: Front of building (Side 1)

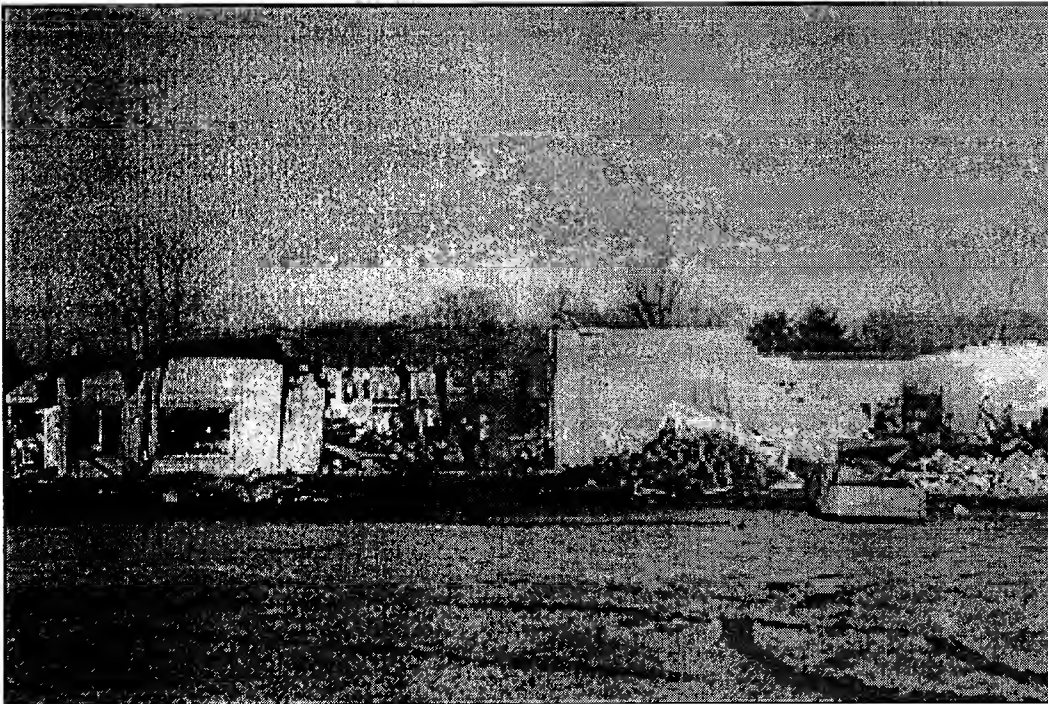
Photo 2: Left side of building looking from front to rear (Side 2)

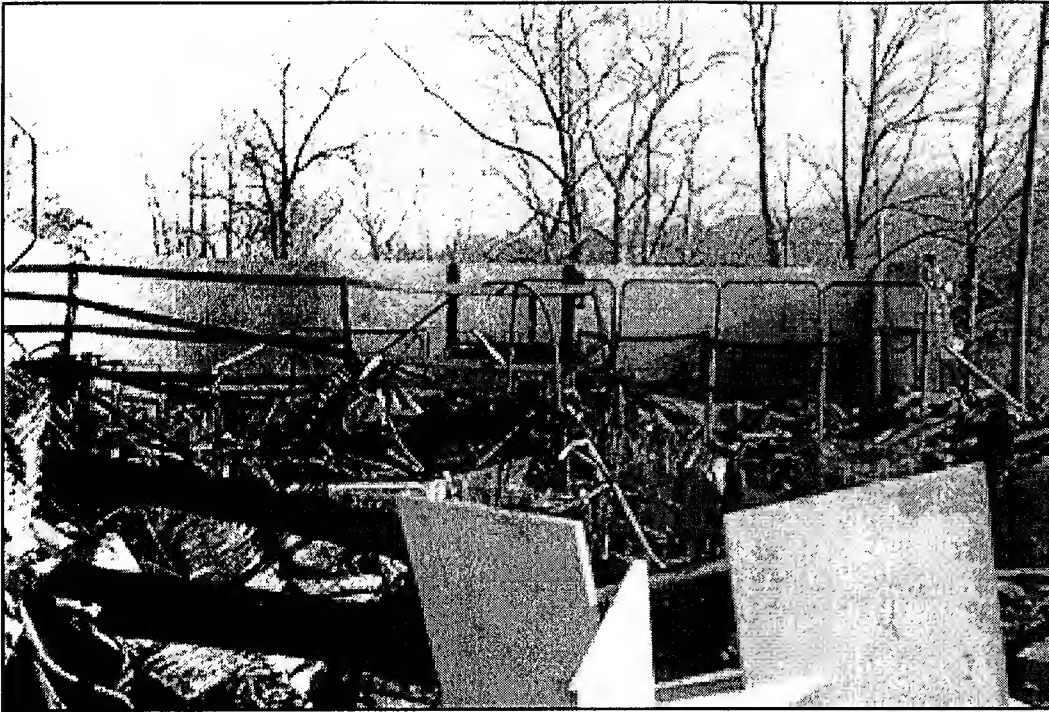
Photo 3: Corner of building between rear and right sides (Sides 3 and 4)

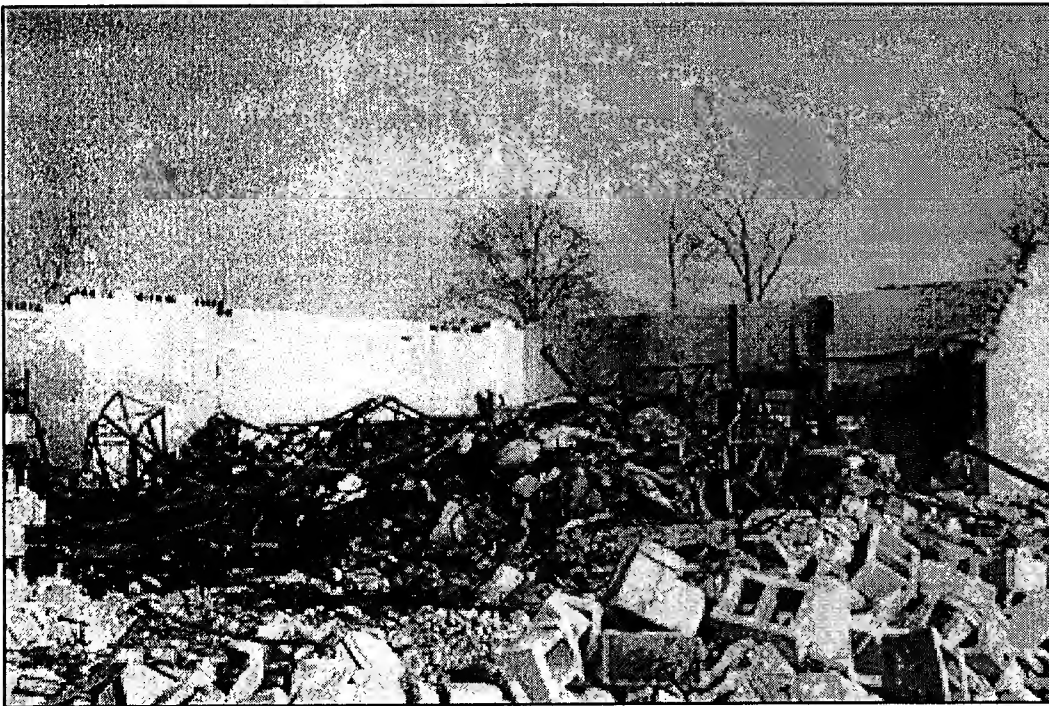
Photo 4: Right side of building (Side 4)
Note: The men are standing in an area where walls had been removed for the cause investigation

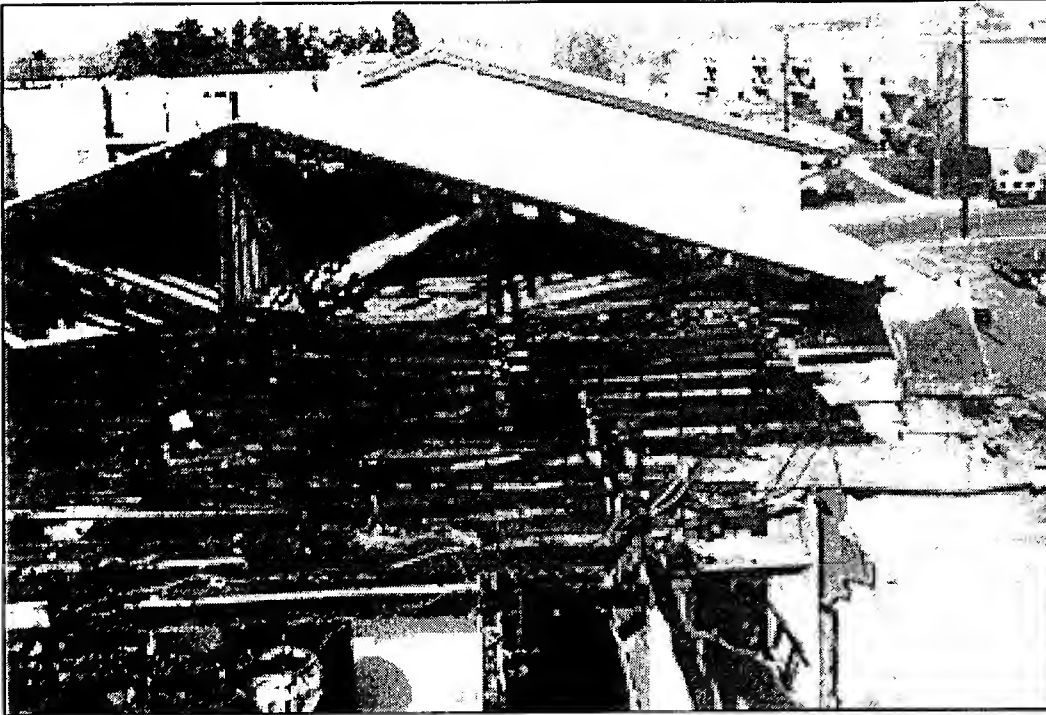
The distance between supports for a truss (i.e., the truss's span) and the number of partitions under a truss affects the risk that a truss can present to fire fighters. In his book *Building Construction for the Fire Service*, Brannigan recognizes that the risk to fire fighters is less when a space contains a large number of interior partitions because the partitions will support the failing trusses allowing only pieces of the trusses to fall to the floor. (See Photo 5.) The same truss used in a commercial building to provide a wide clear span can fail catastrophically.⁸ Such a catastrophic failure occurred in the Branford carpet store. When the roof above the carpet showroom collapsed, large sections fell landing on shelves, countertops, and the floor. The fallen debris blocked the primary egress path for three fire fighters.

Photo 5: Collapsed roof trusses over an apartment building.
Credit: Francis Brannigan, used with permission
